**Estratégia de Conservação Integrada do Património
Edificado**

Sistemas construtivos tradicionais e materiais naturais

Dissertação apresentada à Universidade de Aveiro para cumprimento dos requisitos necessários à obtenção do grau de Doutor em Engenharia Civil, realizada sob a orientação científica do Doutor Aníbal Guimarães da Costa, Professor Catedrático do Departamento de Engenharia Civil da Universidade de Aveiro e coorientação do Doutor Humberto Salazar Amorim Varum, Professor Catedrático da Faculdade de Engenharia da Universidade do Porto.

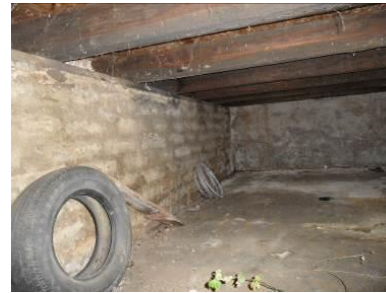
Figure 2-7 - Ventilation space in the base of an adobe construction [credits Alice Tavares]

In some regions, such as the Central region of Portugal or Istanbul (Turkey), adobe constructions included a ventilation space between the ground floor level and the soil level, with holes in the foundation walls to enable air circulation (Figure 2-6, Figure 2-7). This space improved the conservation of the timber and permanent drying of the wall base (Tavares A et al. 2010a). As mentioned in Alberti's treatise, this issue is an important aspect that can also be observed in old stone masonry constructions. Another example is noted by Sahin in relation to the base of traditional buildings in Turkey: a timber beam is placed on a stone platform inside the foundation walls and joists are placed on this beam. Between the stone platform and the pressed earth, is an air space for ventilation, which ranges from 0.20 - 0.30 m. From the end of the 19th century to the mid-20th century, the ventilation space (Sahin N 1995) in constructions in the central region of Portugal (Figure 2-6), usually consisted of more than 0.50 m (Figure 2-7).

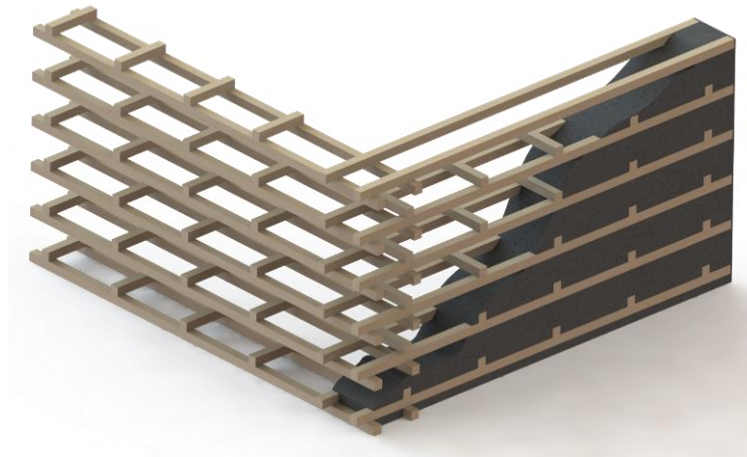
Figure 2-12 - Greek laced masonry based on the work of Sakellariopoulou M. (Sakellariopoulou M 2009), without scale [credits Alice Tavares].

The main difference between the Greek system (Figure 2-12) and the *taq* system is that the latter is dependent on the dimensions of the horizontal timber elements, which are larger and assume the function of beams that line the walls. The distance between the horizontal timber layers is significant and the layers generally have connections with the beams of the floor.

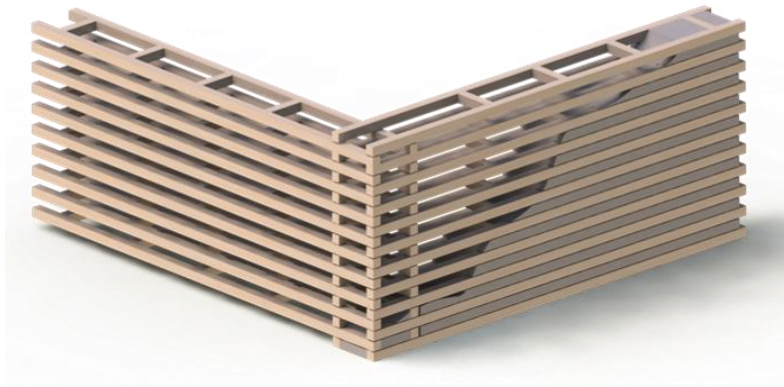
Figure 2-13 - Scheme based on the work of Hughes R. (Hughes R 2000) of an antique defensive tower wall, Pakistani *cator* and cribbage system, without scale [credits Alice Tavares].

mm and horizontal beams that are placed on both sides of the wall at vertical spacing from 0.30 m to 1.30 m. “In better constructed walls the face timbers are tied together through the wall thickness with joined/nailed cross pieces at 1 to 4 intervals. Where the beam is of insufficient length for the whole length of the wall, two or more pieces are connected with tension resisting scarf joints. Breaks in the integrity of the ring beam may occur at doors and windows” (Hughes R 2000, pp3). The image of Alti Fort Tower in Hunza, Pakistan, as presented by Hughes, shows a denser use of horizontal timber elements given its defensive use. The *cator* system (Figure 2-13) also reveals distinct similarities with the Greek traditional system; for example, the system in Lesvos Island. Both of these systems employ horizontal timber elements, such as beams that face both sides of the width of the wall. In addition to the function of confining the masonry infill, a more regular spacing of the horizontal elements and their larger dimensions yields more robust wall corners compared with the Greek system.

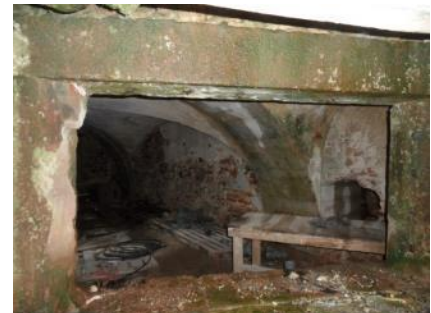
Figure 3-22 – Void space of ventilation at the level of basement/foundations [credits Alice Tavares]

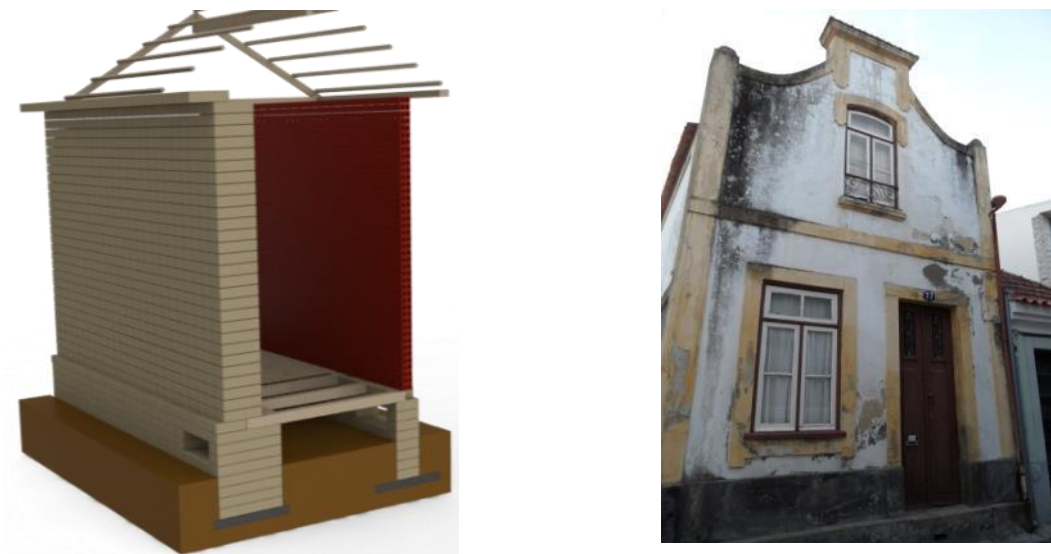
Figure 3-29 – Adobe traditional construction system with timber floors and roof structure [credits Alice Tavares]

An added value of the adobe construction (Figure 3-29) is the strategic existence of a ventilation space between the level of the ground floor and the soil level. Ventilation in this area is guaranteed through small openings at opposite walls, including at the foundations of the interior walls, which allow air circulation throughout the area (Tavares A et al. 2011-a, 2012-a). Normally, the foundation walls rise 0.50-0.60 m above the soil, forming a wall cavity that enables ventilation at both the base of the wall and the wooden floor, thereby facilitating the drying process (Tavares A et al. 2014).

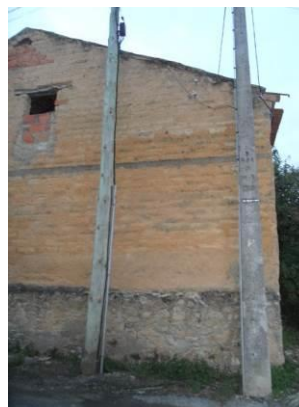
Figure 3-33 – Photo of an
example of RgB solution
[credits Alice Tavares]

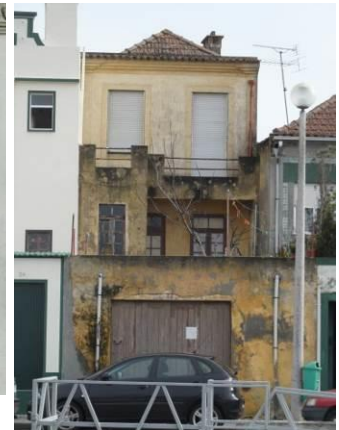
Figure 3-36 – Photo of building (RgB/S solution) [credits Alice Tavares]

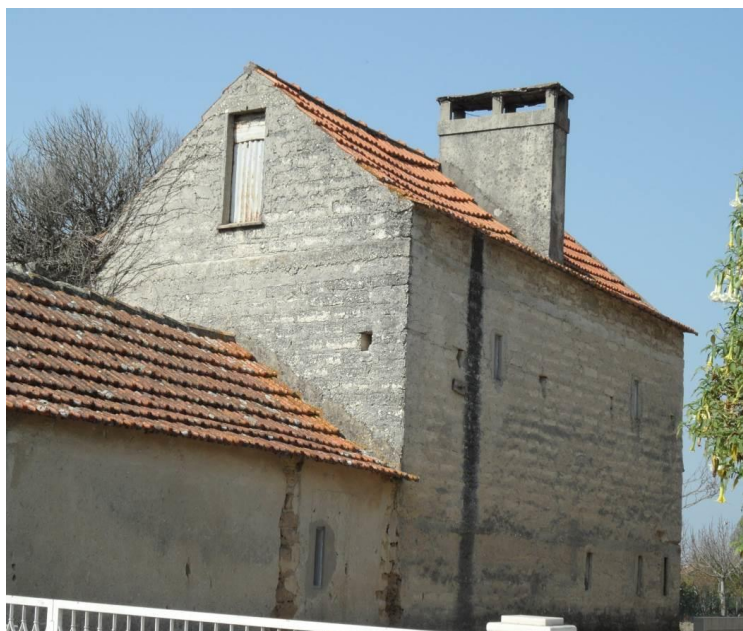
Figure 3-41 – Adobe building with reinforced concrete ring beams [credits Alice Tavares]

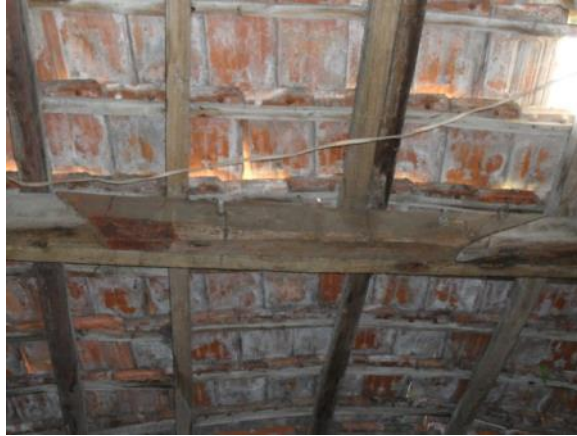
Figure 3-55 – Amendement of purlins [credits Alice Tavares]

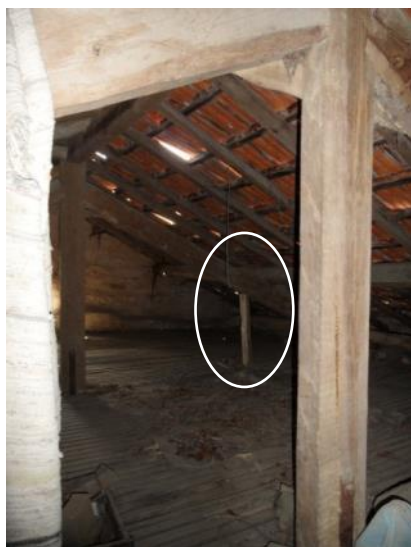
Figure 3-57 – Addition of an upright to help in the support of deformed rafter [credits Alice Tavares]

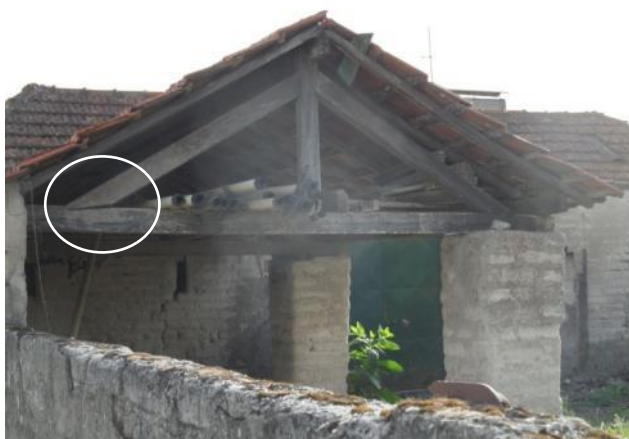
Figure 3-60 – Displacement of the rafter in the connection to the chord or tie beam [credits Alice Tavares]

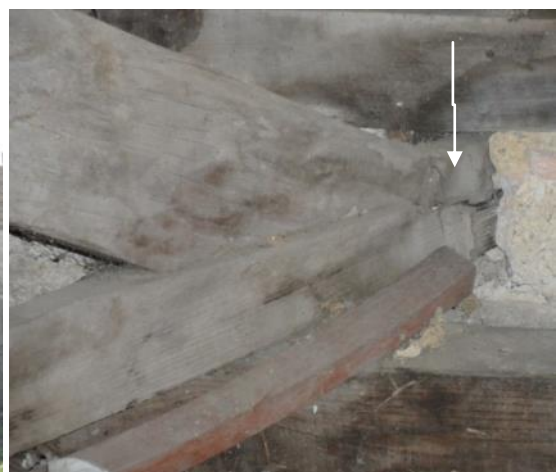
Figure 3-61 – Decay of the connection rafter/chord or tie beam [credits Alice Tavares]

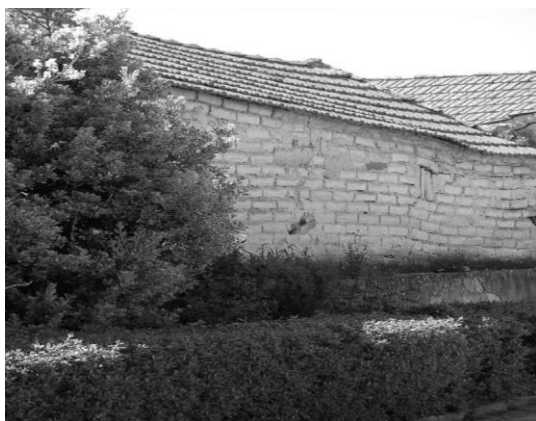
Figure 4-66 - Photo of a building with subsidence damage to the exterior walls and roof [credits Alice Tavares]

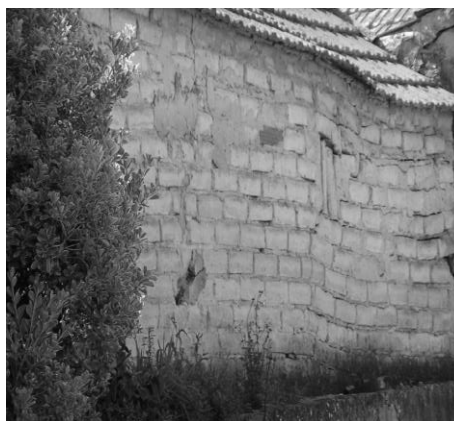
Figure 4-67 - Detail photo of damage caused to walls due to foundation subsidence [credits Alice Tavares]

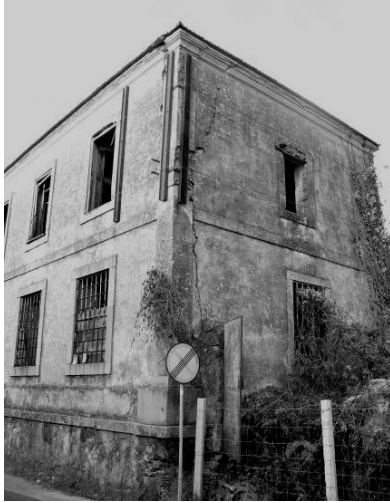
Figure 4-72 - Photo of a building with corner degradation (Eça de Queiroz's family house, Verdemilho) [credits Alice Tavares]

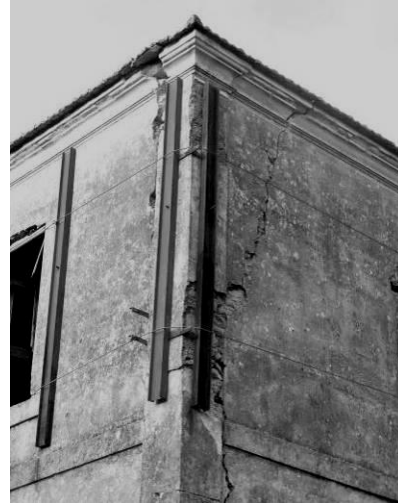
Figure 4-73 - Detail photo of the degradation at the upper part of the corner [credits Alice Tavares]

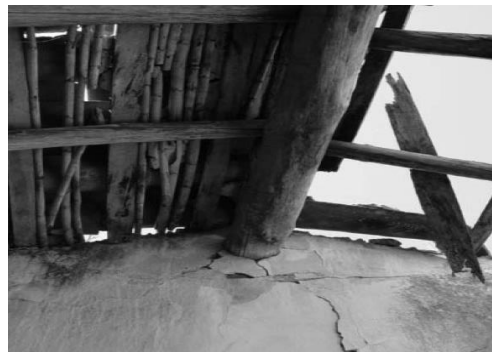
Figure 4-74 - Detail photo of a crush located at covering level [credits Alice Tavares]

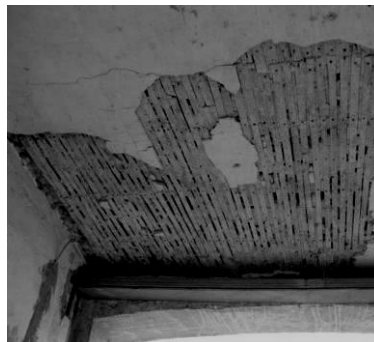
Figure 4-77 Damage to the plaster ceiling [credits Alice Tavares]

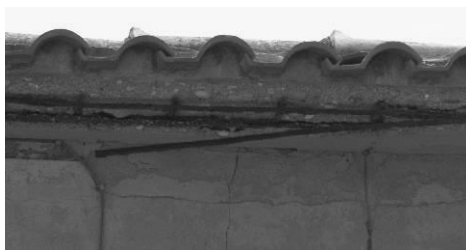
Figure 4-80 - Steel corrosion in reinforced
concrete beams [credits Alice Tavares]

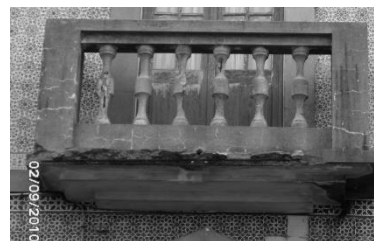
Figure 4-81 - Steel corrosion in
the concrete of a balcony [credits
Alice Tavares]

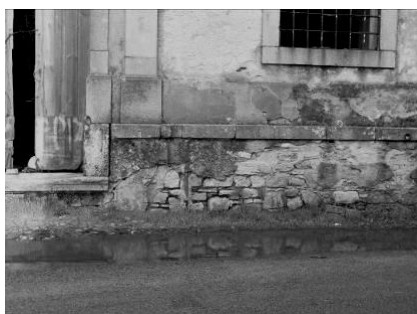
Figure 4-82 - Photo of the degradation of the building stem wall [credits Alice Tavares]

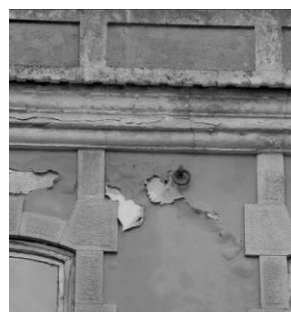
Figure 4-84 - Photo of the degradation of outside paint covering [credits Alice Tavares]

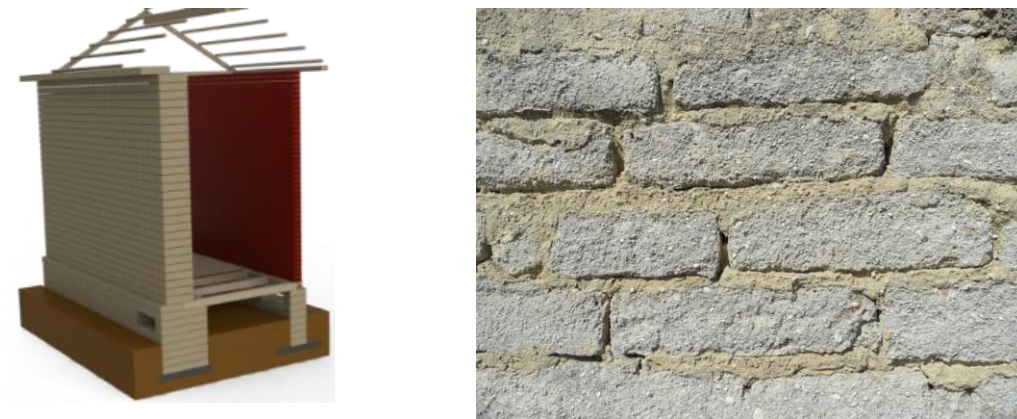
Figure 5-103 - Traditional adobe Construction system and photo of adobe masonry [credits Alice Tavares]

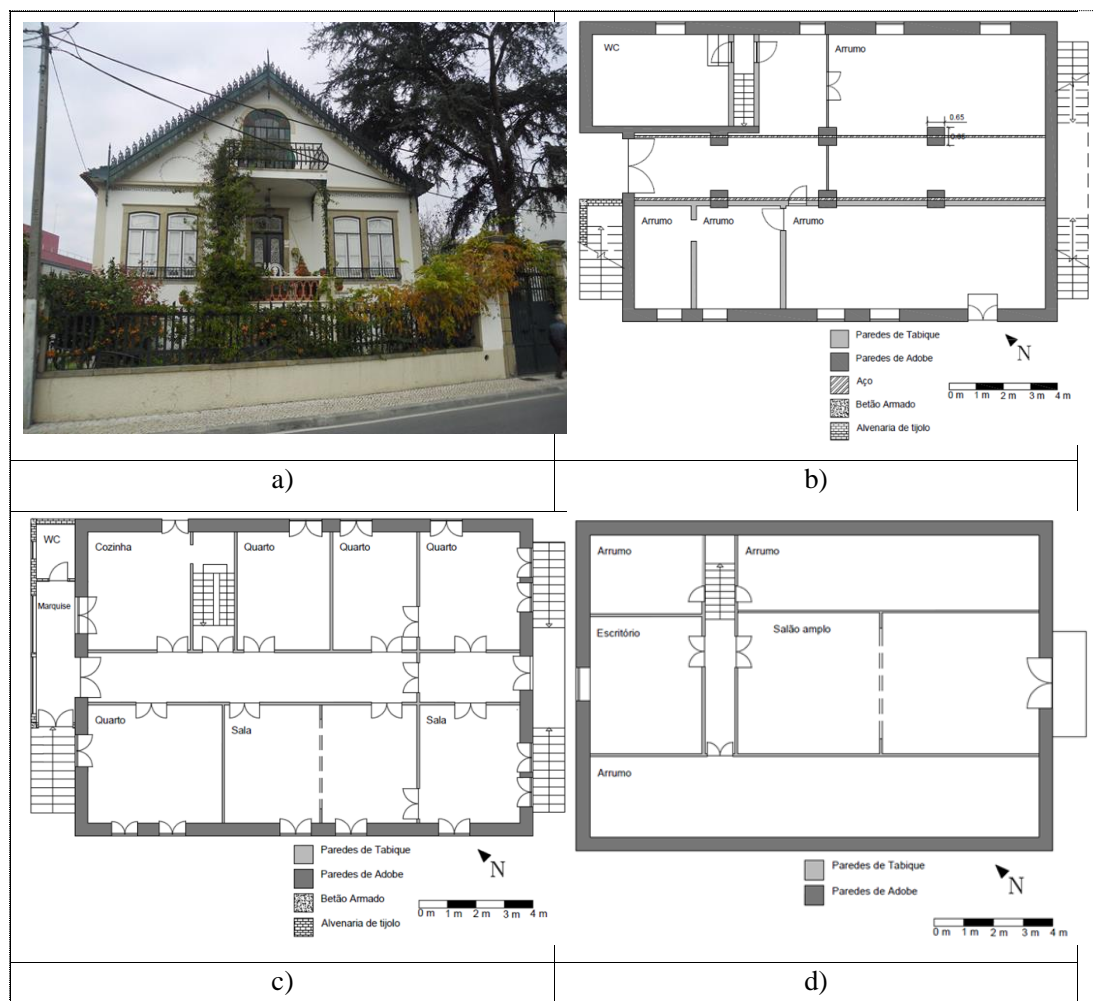
Figure 5-105 – Configuration of case-study building. a) Principal facade; b) Groundfloor plan; c) First level plan; d) Attic plan [credits. Diana Cancela].

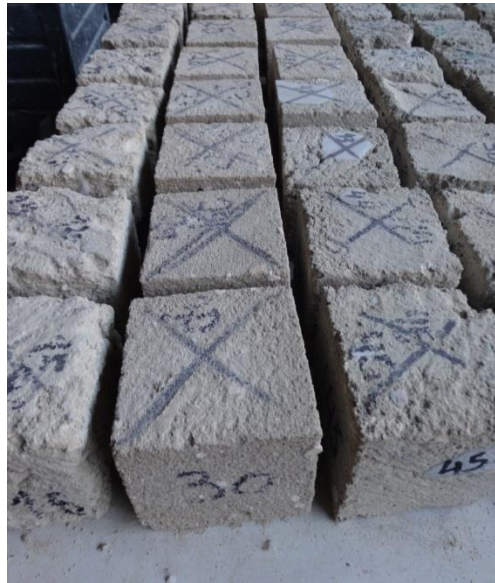
Figure 5 -114 Adobe blocks cut and numbered for the specimens blocks

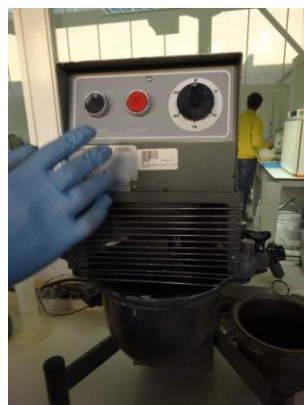
Figure 5 -115 - Mechanical mixer of epicyclical type with two speeds used
